Evaluation of stability of cutslopes in open cast metal mines using numerical modelling and field monitoring

S. Jayanthu¹, Guntha Karthik^{2*}

Mining Engg Dept., NIT Rourkela, Odisha, India

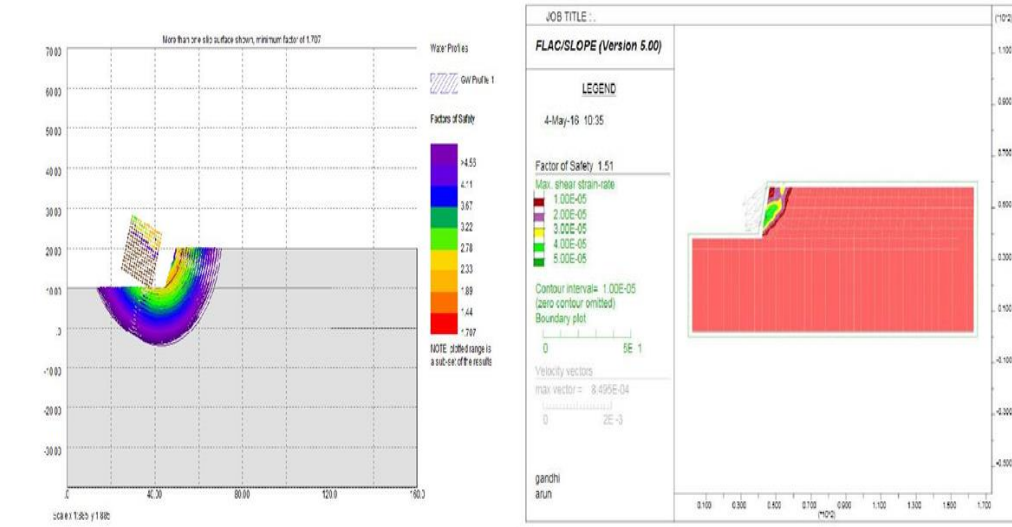
Figure 1. Oasys and FLAC modeling of cut slope of part II mine area having slope height 35m, and slope angle 60°

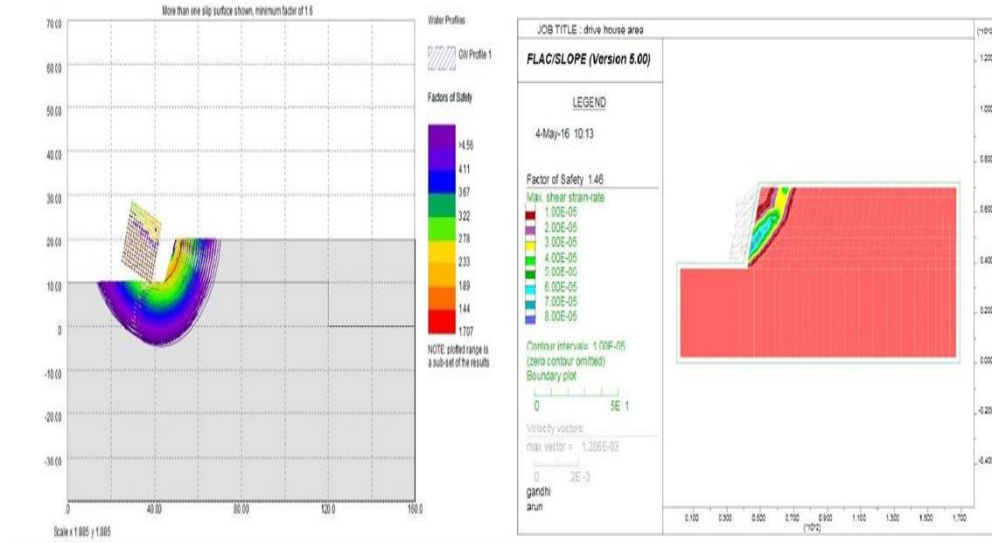
Figure 2. Oasys and FLAC Modeling of cut slope of drive house area having slope height 32m, and slope angle 74°

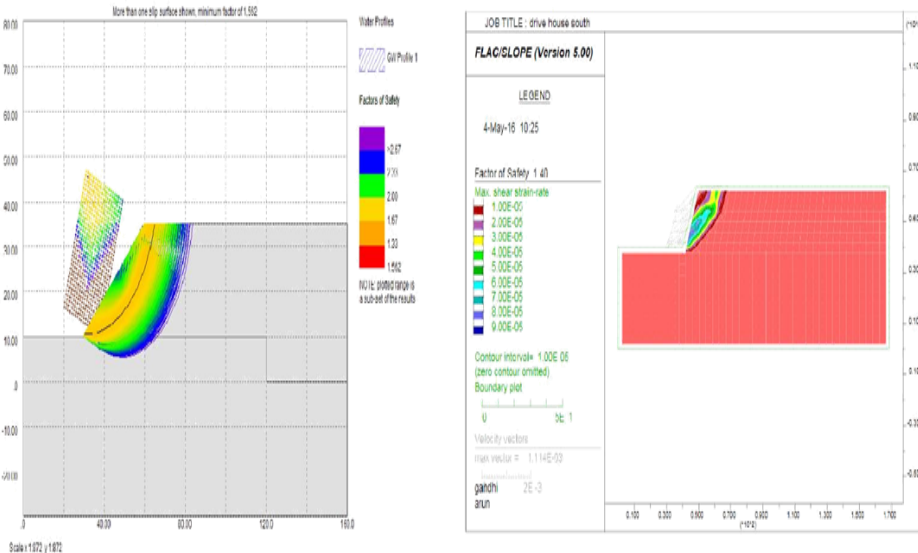
Figure 3. Oasys and FLAC modeling of cut slope of drive house area having slope height 24m and slope angle 70°

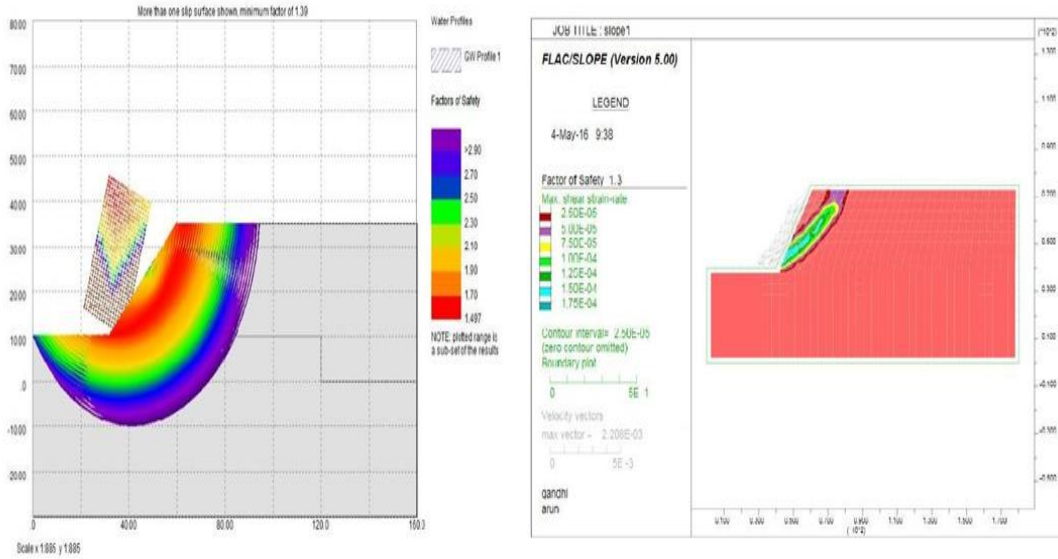
Figure 4. Oasys and FLAC modeling of deep cut area
