Landslide Mechanism of a Slope in Nanhuan Road, Funxin, Northeast China

Abstract

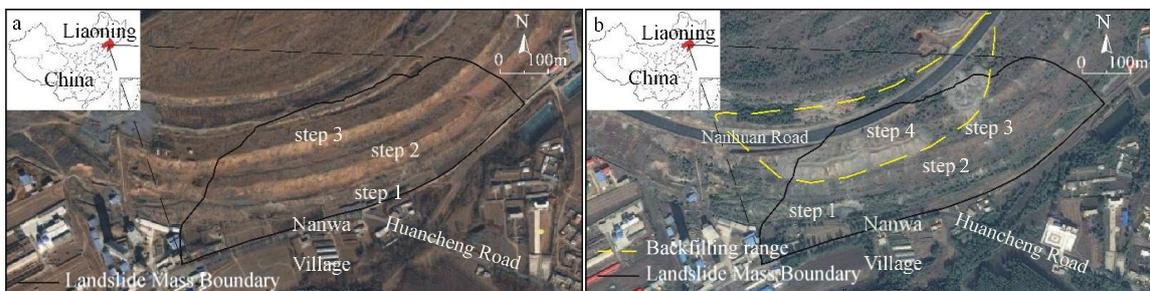
Fig.1. Location of the Study Area (a. Before backfilling b. After backfilling)

The study area and the location of the slope are shown in Fig.1. The clear steps on the slope reflect the stages of backfilling by the surrounding mines. A three steps slope was formed at the end of backfilling in 2004 (Fig.1.a). The slope was originally stable and free from deformation. However, the stability was undermined by the construction of Nanhuan Road from March to September 2012. The road crossed the top of the original slope at Step 3 from northeast to southwest. A largescale backfilling was carried out to meet the road design requirements. The backfill formed a new step (Step 4) atop the original slope (Fig.1.b). After the construction, the slope can be divided into four steps, each of which consists of a 25~35° slope and a relatively flat platform. From bottom to top, Step 1, Step 2 and Step 3 are all 20m tall, and Step 4 is about 15m in height (Fig.1.b).

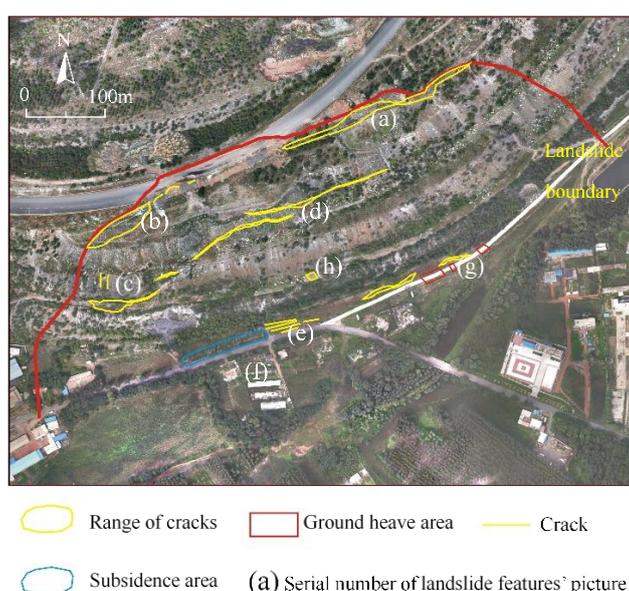
Fig.2. Location of Landslide Features in the Site Survey in September 2015

In August 2013, the first sign of ground heave was recorded at the intersection of Yimin Road and Huancheng Road at the bottom of the slope. Besides, cracks and sliding features were discovered on the slope of Step 1. Two months later, the area of cracked pavement on Nanhuan Road further expanded, leaving three obvious cracks on the pavement. The cracks were up to 340m in length and 1~30cm in width. The height difference between the two sides of crack was 20cm at the most. According to the observation data, the maximum road settlement was 15.1cm, and the maximum crack width was 12cm from August to September in 2013.

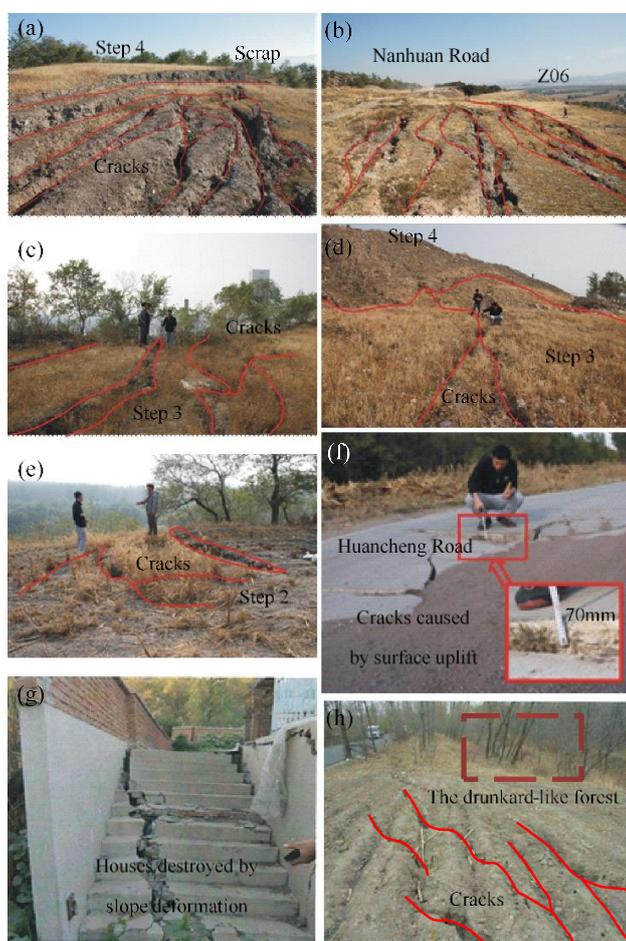
Fig.3. Most Evident Damages of the Nanhuan Road Landslide

As the road continued to settle with the deformation of the slide mass, a number of backfills were performed on the subsidence section by the road maintenance department. The site survey in September 2015 shows that the total pavement settlement had surpassed 5m, clear boundaries had formed around the slide mass, and a number of cracks had formed on the surface of the slide mass (Fig.2.). At the bottom of the slope, the deformation had induced uneven settlement of Yimin Road, ground heave in the surrounding residential areas, and cracking on the walls of residential buildings (Fig.3.).

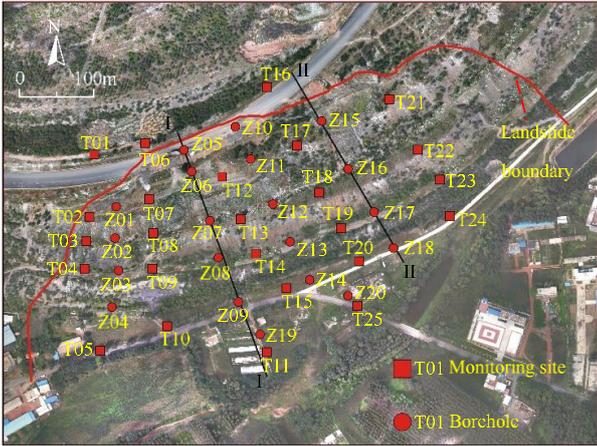
Fig.4. Location of Monitoring Points, Boreholes and Section Lines

location of monitoring points, boreholes and section lines, and illustrates the distribution of slope deformation features. Fig.5. details a typical longitudinal section I-I' extracted from Fig.4. and displays the stratigraphic information obtained from the boreholes. As shown in the figure, the slope is formed with the slags produced by surrounding mines. The upper part of the gangues is a 4.2~64.4m thick layer of sandstone, mudstone and sub-clay, while the lower part of the gangue is a 1.2~12.0m thick layer of silty clay. The lower part used to be the surface soil layer before the accumulation of slags. The bedrock is composed of weathered sandstone. The ground water table was measured based on the monitoring results of drilling. The relevant engineering geological parameters of the slope were tested according to the relevant requirements of the Code for Investigation of Geotechnical Engineering (GB50021-2009). The test results are summarized in Table 1.

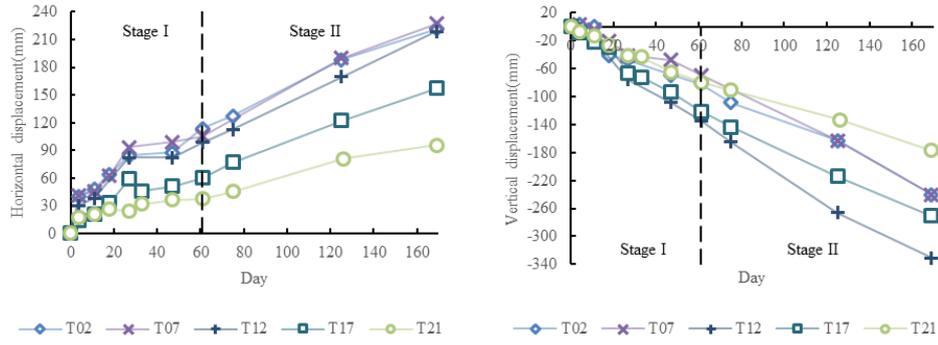
Fig.6. Displacement of Step 4

On the top platform (Step 4) of the slope (Fig.6), all the monitoring points underwent obvious displacement in the horizontal direction. The horizontal displacement increased with the monitoring time. During the monitoring process, the most pronounced displacement increments were measured at T02, T07 and T12, all of which fell in the range of 219mm~227mm at the end of Phase 2. In the vertical direction, all the monitoring points on this platform exhibited apparent settlement. The vertical settlement also increased with the monitoring time. The most prominent vertical settlements were measured at T12 and T17 in Phase 1. The settlement values of T07, T02 and T21 were very close to each other. In Phase 2, the settlement of T21 gradually slowed down. At the end of Phase 2, T12 and T17 had the greatest settlements (331mm vs. 271mm), followed by T02 and T07, both of which shared similar degree of settlement (240mm); the minimum settlement was observed at T21 (177mm).

To sum up, T12 underwent the significant displacement in both directions, T02 and T07 were mainly displaced in the horizontal direction, T17 was mainly displaced in the vertical direction, and T21 had unobvious displacement in either direction.

For the monitoring points on Step 4, the horizontal displacement was consistent with the sliding direction of landslide, and the vertical deformation was displayed as settlement. The settlement of the monitoring points (T02, T07, T12) in backfill area was greater than the one (T21) in the original area.

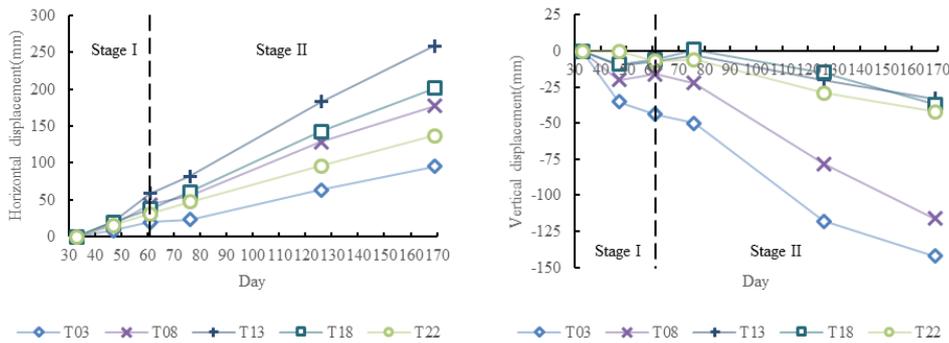
Fig.7. Displacement of Step 3

The monitoring points in Step 3 of the slope exhibited different displacement features (Fig.7). The monitoring points underwent horizontal displacement along the direction of the slope, and the displacement value increased steadily with the growth of the monitoring time. At the end of Phase 2, the monitoring points were ranked as T13> T18> T08> T22> T03 in descending order of displacement. In the vertical direction, each monitoring point in this platform underwent significant deformation. The settlement also increased steadily with the growth of the monitoring time. At the end of Phase 2, T03 and T08 had the most obvious settlements (142mm vs. 116mm), while the settlements of T13, T18 and T22 fell in the interval of 37mm~42mm.

In short, T08 underwent the significant displacement in both directions, T13, T18 and T22 were mainly displaced in the horizontal direction, and T03 was mainly displaced in the vertical direction.

Step 3 was formed by the accumulation of slags. The shape of the slope had a great impact on the horizontal deformation. Under the impact, the monitoring points on the edge (T03, T22) underwent the smallest horizontal displacements, while the monitoring point in the protruding position (T13) had a much greater horizontal displacement. At the beginning of the monitoring, T03 boasted the greatest vertical displacement under the action of the backfill subgrade on Step 4. The deformation of T03, in turn, affected the surrounding area, such as inducing major growth of the vertical displacement of T08. With less impact of backfill and surrounding settlement, there was no significant increase in the vertical displacements of T13, T18 and T22.

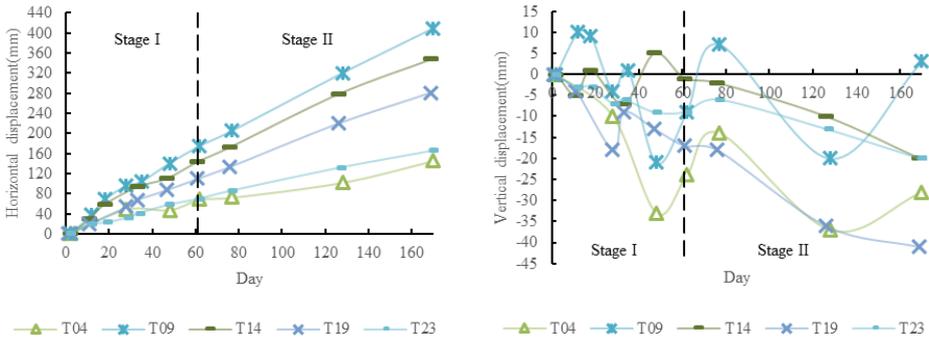
Fig.8. Displacement of Step 2

As shown in Fig.8, all of the monitoring points on Step 2 exhibited obvious displacement in the horizontal direction, which increased with the monitoring time. At the end of Phase 1, the monitoring points were ranked as T09> T14> T19> T23> T04 in descending order of displacement. In the vertical direction, the monitoring points differed markedly in the deformation trend. As the

monitoring time increased, the vertical settlement of the monitoring points showed great uncertainty. For instance, T04 experienced varied degrees of settlement and uplift during the monitoring: the final trend was settlement (28mm) at the end of Phase 2. For the monitoring point T09, the vertical deformation was an uplift (max: 10mm) at the beginning of Phase 1, the uplift and settlement appeared alternatively during Phase 1, and trend was settlement (9mm) at the end of Phase 1; the uplift and settlement appeared alternatively again during Phase 2, and the final trend was uplift (3mm) at the end of Phase 2. The monitoring point T14 experienced uplift (max: 5mm) and settlement (max: 7mm) alternatively during Phase 1. During the monitoring period, the displacement trend of T19 was mainly manifested as settlement, and the final settlement was 41mm at the end of Phase 2. For the monitoring point T23, settlement was the main displacement trend in Phase 1 and the final settlement reached 20mm at the end of Phase 2; of course, there was a slight uplift trend at the beginning of Phase 2.

Step 2 had a similar horizontal displacement to Step 3. The monitoring points on the edge (T03, T22) underwent the smallest horizontal displacements, while the monitoring point in the protruding position (T09, T14) had the largest horizontal displacements. In the vertical direction, the monitoring points on Step 3 experienced irregular uplift and settlement during the monitoring period. Hence, it is assumed that Step is located on and affected by multiple sliding surfaces.

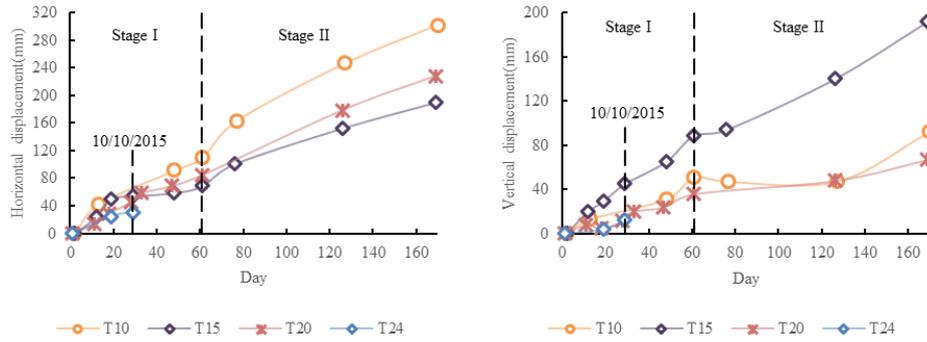
Fig.9. Displacement of Step 1

As shown in Fig.9, all of the monitoring points on Step 1 exhibited obvious displacement in the horizontal direction. At the end of Phase 2, the monitoring points were ranked as T10> T20> T19> T15 in descending order of displacement. There was also significant deformation in the vertical direction at these monitoring points, that is, a steady increase in the uplift with the growth of the monitoring time. At the end of Phase 2, the maximum uplift occurred at T15 (192mm). T10 and T20 had similar uplifts, which varied between 67mm and 92mm.

Situated at the bottom of the slope, Step 1 was severely squeezed by the upper sliding mass. Under the squeezing effect, the monitoring points on the step exhibited a large displacement. The effect of the sliding mass also led to the pronounced uplift at the bottom.

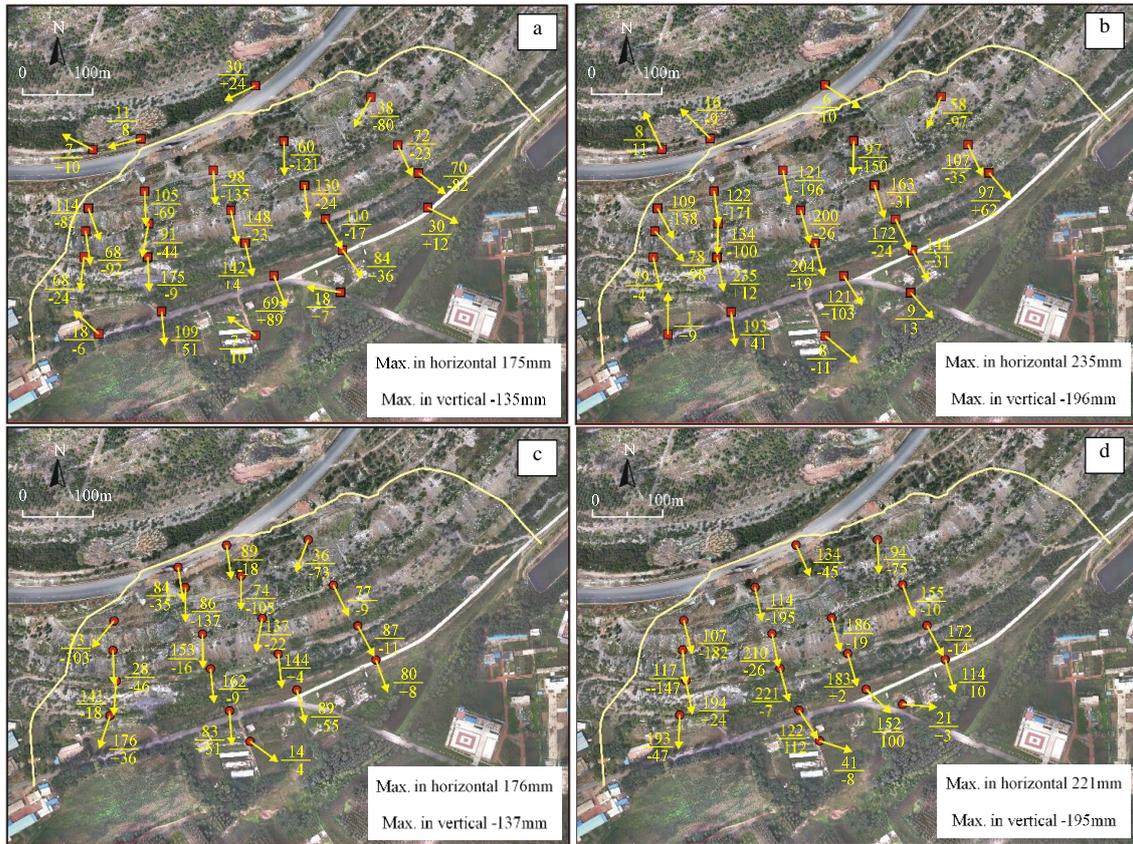
To determine the sliding direction of the whole slope, the author took the first measured coordinates of the monitoring points and boreholes as the base points, and calculated the displacement and directions of each monitoring point by adding up the measured data from two different measurement phases (Fig.10). The monitoring points with an error no greater than 30mm in the horizontal direction and 20mm in the vertical direction were called relatively stable points. According to cumulative displacement in the two phases, T01, T05, T06, T11, T16, T24, T25 (monitoring points) and Z15, Z20 (boreholes) were named as relatively stable points.

In Phase 1 (Fig.10.a, c), T09 was the most horizontally displaced monitoring point (175mm), T12 was the most vertically displaced monitoring point (135mm), Z03 was the most horizontally displaced borehole (176mm), and Z06 was the most vertically displaced borehole (137mm). The measured results of Phase 2 are independent of those of Phase 1. In Phase 2, the displacement of each monitoring point increased in varied degrees (Fig.10.b, d). The results are as follows: T09 was the most horizontally displaced monitoring point (235mm), T12 was the most vertically displaced monitoring point (196mm), Z08 was the most horizontally displaced borehole (221mm), and Z06 was the most vertically displaced borehole (195mm).

Sorting out the monitoring results, it was concluded that the horizontal displacements of the monitoring points fell in $150^{\circ}\sim 180^{\circ}$. According to the direction of displacement, the landslide was determined as south-trending, and the middle part of the sliding mass was the hotbed of landslide.

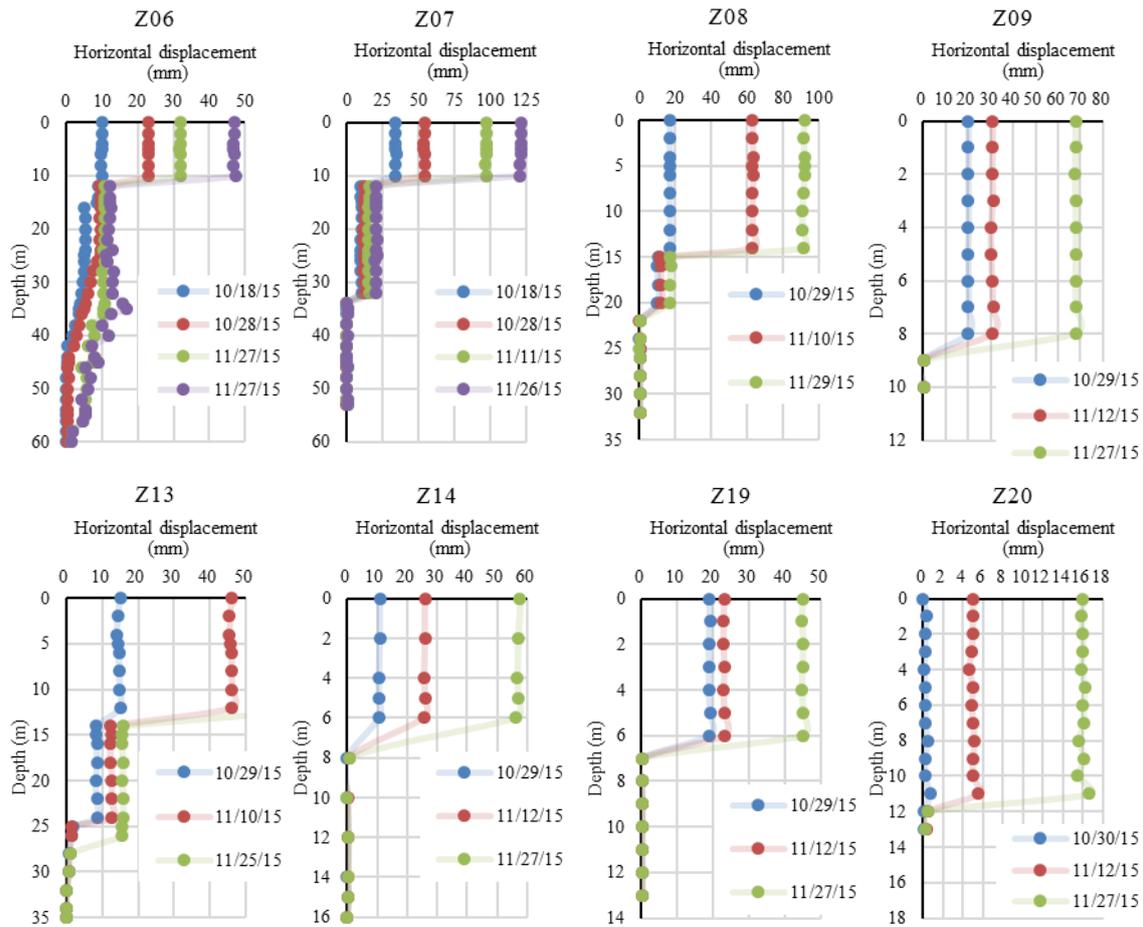
Fig.11. Horizontal Displacement Profiles of the Slope

After the site survey, the inclinometer measurement of the slope was conducted from October 2015 to November 2015. With the boreholes as the monitoring holes, an inclinometer was adopted to measure the horizontal displacement of each borehole at different depths. The selected boreholes include Z06 (depth: 60m), Z07 (depth: 53m), Z08 (depth: 32m), Z09 (depth: 10m), Z13 (depth: 35m), Z14 (depth: 16m), Z19 (depth: 13m) and Z20(depth:13m). During the measurement period, Z06 underwent 1 relative displacement at the depth of 15m; Z07 underwent 2 relative displacements at the depths of 10m and 32m; Z08 underwent 2 relative displacements at the depths of 14m and 20m; Z09 underwent 1 relative displacement at the depth of 8m; Z19 underwent 1 relative displacement at the depth of 6m. The measurement results reveal that the slope was still in the process of sliding. The locations of two sliding surfaces can be initially identified based on the site survey and inclinometer measurement.

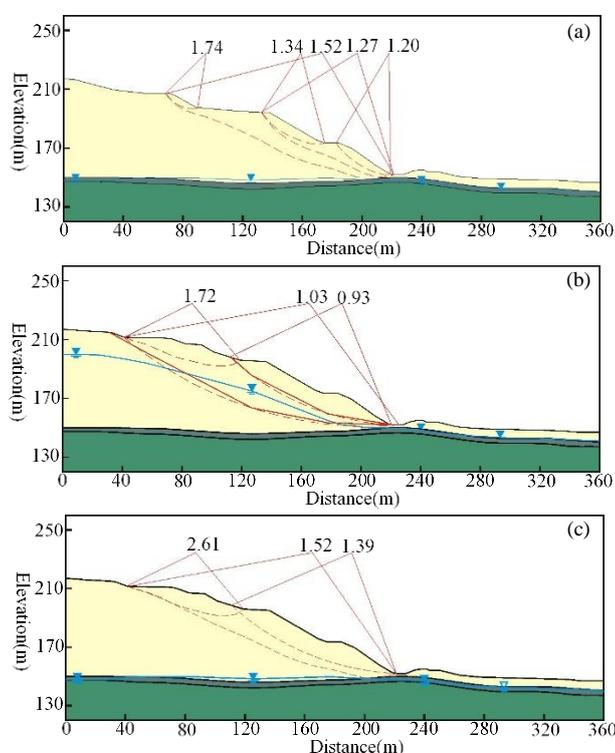
Fig.12. Slope Stability Analyses in Different Conditions (a. Before backfill b. After backfill c. The effect of rainfall infiltration)

In condition 1, the whole slope consisted of 3 steps. The safety factor was 1.52 for the whole slope, 1.27 for Steps 1 & 2, and 1.20, 1.34 and 1.74 for each of the three steps in ascending order. The safety factors demonstrate that the slope was in the stable state in condition 1 (Fig.12. (a)).

after checking the stability of each step. The safety factor was 1.52 for the whole slope, 2.61 for Steps 3 & 4, and 1.39 for Steps 1, 2 & 3. The safety factors indicate that the slope was still in the stable state in condition 2 (Fig.12. (b)).

In condition 3, the groundwater table rose in the slope under rainfall infiltration. The slope stability was checked in the same way as in condition 2. The safety factor was 1.03 for the whole slope, 1.72 for Steps 3 & 4, and 0.93 for Steps 1, 2 & 3. This means the slope was in the failure state (Fig.12. (c)).

The calculated results are in good agreement with the data measured by the inclinometer. The two slip surfaces are basically reasonable, because the slags were not accumulated evenly year after year.

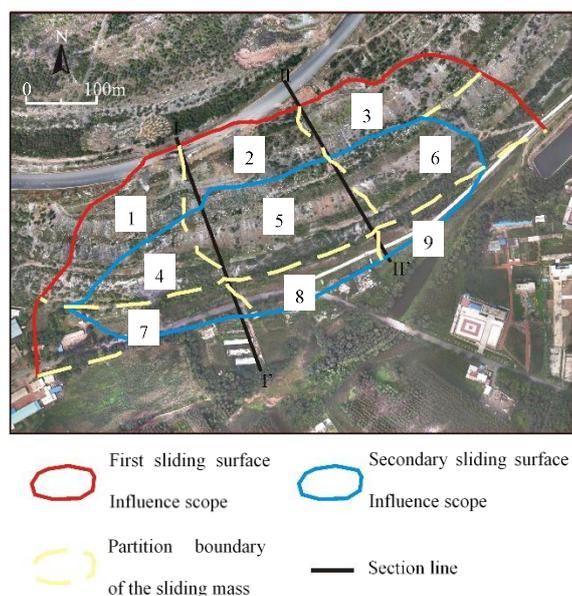
Fig.13. Segmentation of the Slide Mass Based on the Investigation Results

Based on the results of site survey, surface displacement monitoring, inclinometer measurement and limit equilibrium, the slide mass was segmented according to the sliding rate and the deformation features (Fig.13.).

Region 1: According to the results of surface displacement monitoring, this region has the greatest settlement in the sliding area, and a relatively insignificant horizontal displacement. During the construction of Nanhuan Road, the subgrade backfill added to the load on the slope crest, resulting in the settlement of the whole slope. In return, the settlement deformation led to the tensile fracture of the road and shear cracking on the edge of the primary sliding surface.

Region 2: This region is located between the two tensile fractures resulted from the sliding surface. There are two effects of subgrade backfill during the construction of road. On the one hand, the original slope experienced a typical settlement due to subgrade settlement and backfill soil weight; on the other hand, a more pronounced displacement occurred in the main sliding direction under the deformation squeezing of the subgrade backfill. Under the joint effect of horizontal and vertical deformations, Nanhuan Road was displaced by over 5m in this region.

Region 3: Situated on the outside of the subgrade backfill area, this region is still affected by the deformation of the backfill area. The upper part of the region has several tensile fractures, which become narrower as the distance from the backfill area increases. Since the backfill was not conducted in this region, the vertical displacement here is much smaller than that in Regions 1 and 2.

Region 4: This region is located within the secondary sliding surface. The whole slide mass slid down along the slope direction. With the extrusion of deformations in Regions 1 and 2,

however, the stress in the slide mass was distributed abnormally, creating irregular settlement and uplift.

Region 5: Located in the middle of the slide mass, this region shares a similar sliding situation with Region 3. Under the joint action of settlement and sliding in Region 2, the tensile fractures created by the secondary sliding surface tended to expand during the monitoring process.

Region 6: This region partially falls in the secondary sliding surface and partially on the sliding boundary. Hence, it was influenced by the deformation of Region 3 and a part of secondary sliding surface. Of course, the deformation effect from Region 3 was unobvious for the latter stayed beyond the backfill area. Besides, the regional displacement decreased with the increase in the distance from the sliding surface.

Region 7. This region is located in the south of the slope foot. Here, the surface deformation was manifested as uplift. The surrounding buildings were deformed and destroyed, and the pavement of Huancheng Road underwent wavy uplift and tilt.

Region 8: The region is located in the middle of the slope foot. The surface deformation was also manifested as uplift. The walls of the residential buildings were damaged and covered with tensile fissures. The road pavement was hit by severe settlement (max: 5m).

Region 9: The region is located on the north of the slope foot. The surface deformation was exhibited as slight uplift with small regional elevation. The road pavement cracked and slightly uplifted.

(2) Based on the site survey and surface displacement monitoring, the slope was divided into 9 regions in light of the slide mass deformation. Among them, Regions 1, 2, 4 and 5 had the most obvious deformation. These regions should be prioritized in slope management in future research.
