## **Stability Evaluation of Highwall Slope in an Opencast Coal Mine-A Case Study**

\*I. Satyanarayana, \*\*G. Budi, \*\*\*Phalguni Sen, \*\*\*\*A.K. Sinha

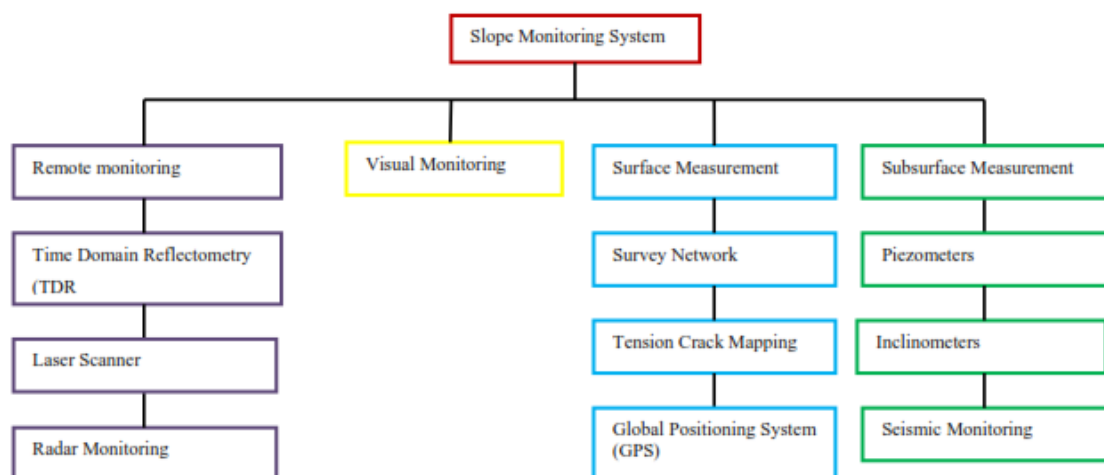
Figure 1.1 Slope Monitoring System (Little M.J., 2016)

Because of the unpredictability of slope behavior, slope monitoring can be of value in managing and preventing slope hazards, and they provide information that is useful for the design of remedial work. As illustrated in figure 1.1, a slope monitoring system can be divided into four sections namely, Visual monitoring, surface measurements, subsurface measurements and remote monitoring technologies. A very cogent factor in an effective slope monitoring system, as pointed out by Little (2006), is the creation of a comprehensive database system for the large volume of geotechnical information obtained from the mine. All data from exploration core logging, face mapping, rock testing, water and slope monitoring must be incorporated into the database system to ensure that no data is lost, and that the data is available for safe and productive slope design.

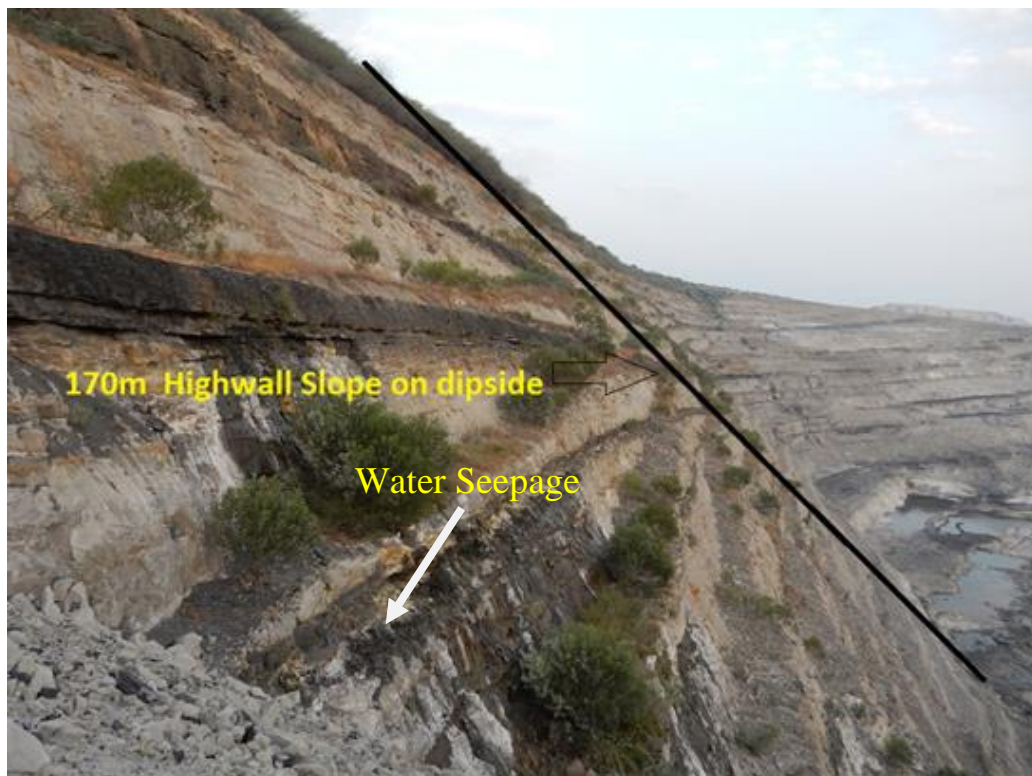
Figure 2.4. Photograph depicting the ultimate of 170m highwall of Medapalli OCP

The plan showing 170m highwall slope of Medapalli OCP towards dip side of the quarry along flood protection bund is shown in figure 2.3. The photograph of 170m pit slope on dip side of Medapalli OCP is shown in figure 2.4.

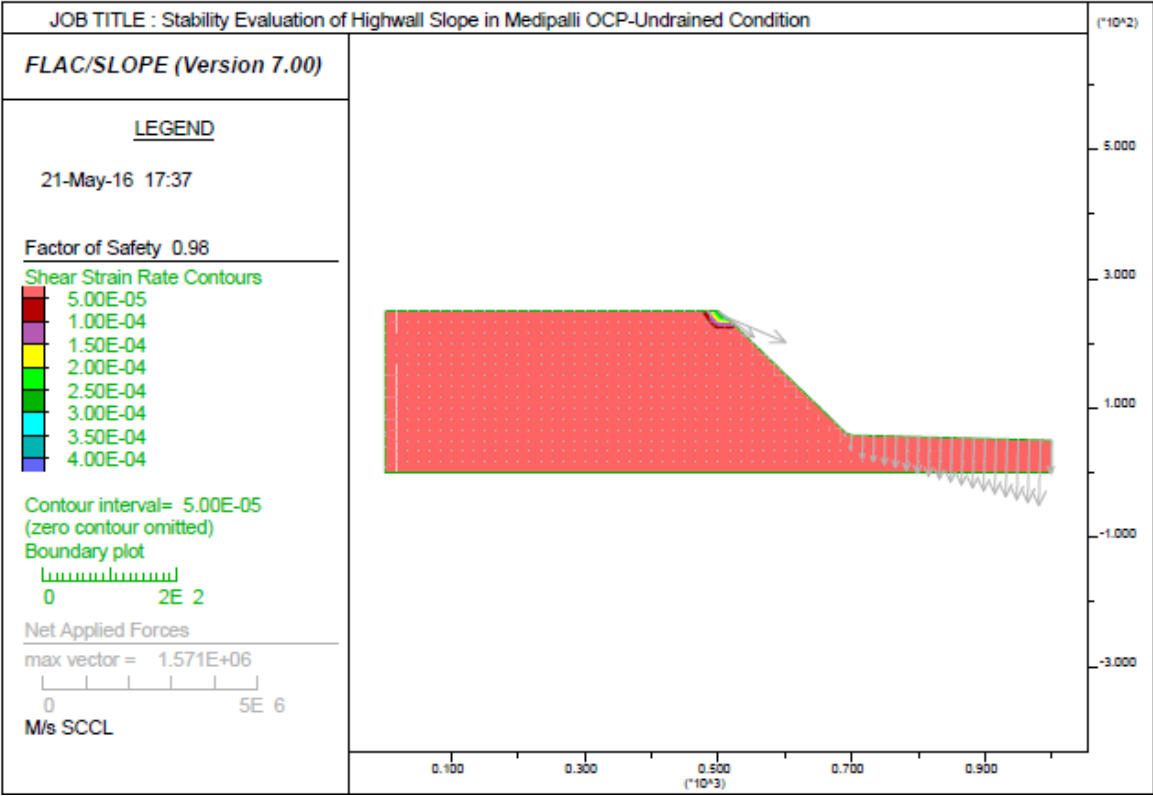
Figure 2.8. Limiting failure surface and factor of safety for FLAC/SLOPE analysis in undrained condition (Overall slope angle-45°)

It is observed from the simulation that the influence of groundwater on factor of safety is remarkable. The results of numerical analysis in undrained condition indicated that the circular

failure is observed in the pit slope at the crest and the factor of safety is 0.98 (figure 2.8). The photographs depicting failure surface, developed cracks and weak strata of pit slope on dipside of mine are shown in the figure 2.11. From numerical analysis, it is found that circular failure of slope is occurred in undrained condition at a distance of around 10m from pit crest to 20m deep which is also evident from field observations (figure 2.11). Circular failure is the basic mode of slope instability in weathered slope material, whereas plane, wedge and toppling failures occur in the hard rockmass.

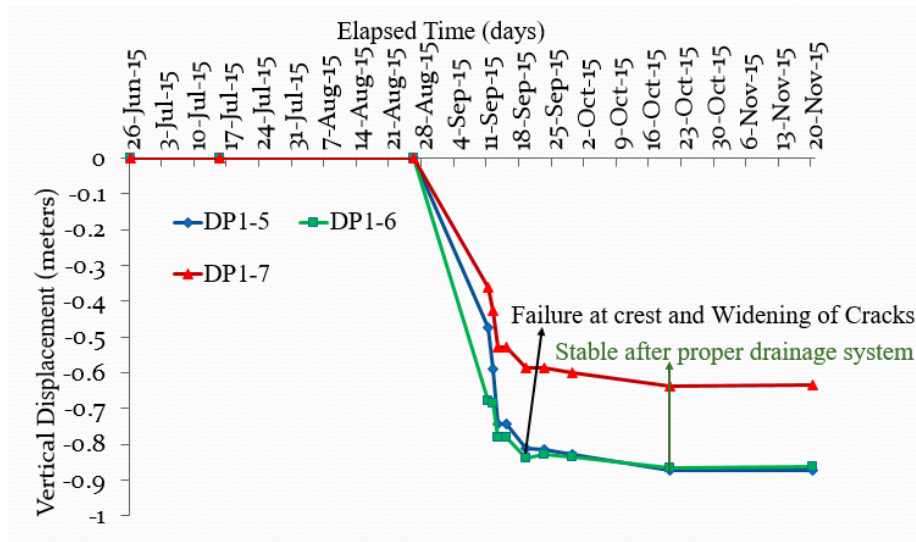
Figure 2.10. The displacement monitored by Cyclops

The automatic theodolite was positioned at a fixed point and measured readings of the all the 50 targets daily. It was observed that prior to development of cracks and failure at crest as shown in figure 2.11, there was no displacement as shown in the figure 2.10 before 26-Aug-15. The development of cracks and initiation of failure at crest was started when there was a displacement of about 40cm shown by Cyclops indicating warning (figure 2.10). The slope gradually started displacing on the 26-Aug-15. The widening of cracks and slope failure at crest were occurred at about 90cm displacement (figure 2.10) on 19-Sep-15. The seepage of water along the slope was also observed due to improper drainage of water (figure 2.4). Erosion brought about by flowing water could also result in reduced strength (Morgenstern, 1971; Sage, 1976; Sharp et al., 1977; Hoek and Bray, 1981). Mining personnel were subsequently withdrawn from the area for safety

reasons and provided adequate drainage system. The Mining resumed from 20-Nov-15 when the cyclops information indicated that the slope had stabilised (figure 2.10). Till date, there is no problem of slope failure. From Simulation analysis, it is found that the simulation predictions are closer to the field data and show much better accordance with the field results.

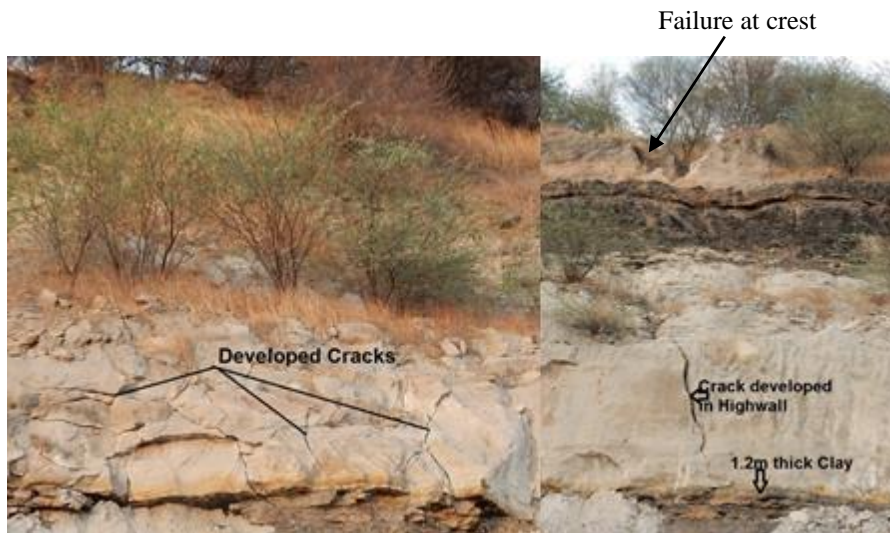
Figure 2.11. The cracks developed due to dipside highwall failure at Medapalli OCP
