Energy efficiency improvements in historic buildings: Analysis of a case study in central Italy

Paolo Zazzini^{1*}, Marco Capone²

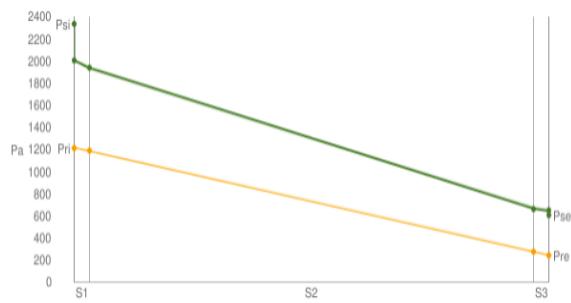
Figure 3. Diagram of Glaser for external walls

Figure 3 highlights that the external walls are not subjected to condensation, while in Figures 4 and 5 it is evident that condensation takes place in the wood cover and in the masonry cover.

The external vertical walls have a thermal transmittance U of 0.95 W/m² K, higher than the value indicated by law of 0.36 W/m²K, while the wood cover presents a U value of 2. 61 W/m² K and the value of law is 0.28 W/m² K. Finally, the masonry cover has a transmittance value of 1.12 W/m² K, higher than the value of law of 0.28 W/m² K.

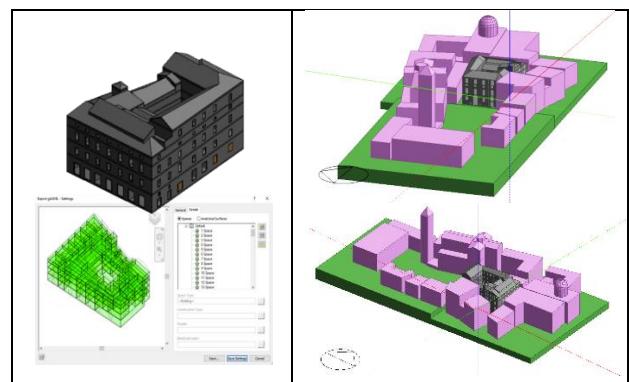
Figure 6. Three-dimensional models of the building

After analyzing the existing state of the building the authors propose some improvement interventions and evaluate the energy saving benefit for each one. In Figure 6 the three-dimensional models of the building are shown.

The DesignBuilder software, equipped with the calculation engine Energy-plus, has been used to determine the building's energy performance. The three-dimensional model of the building has been designed by the software Autocad and Revit and exported in DesignBuilder. The building's energy performance in dynamic conditions have been calculated after setting its thermo-physical parameters and the external climatic conditions.

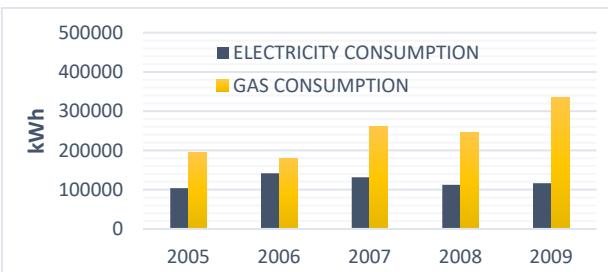
Figure 7. Annual Electricity and gas consumptions

Real energy consumption data of Valignani Palace have been compared to data from DesignBuilder simulation in the considered climatic zone [16], in order to validate the simulation model. The annual energy consumption of the building of the five years preceding the 2009 earthquake have been taken into account, as shown in Figure 7.

Data comparisons were carried out both on gas and electricity energy uses and a good agreement is verified, as shown in Table 3.

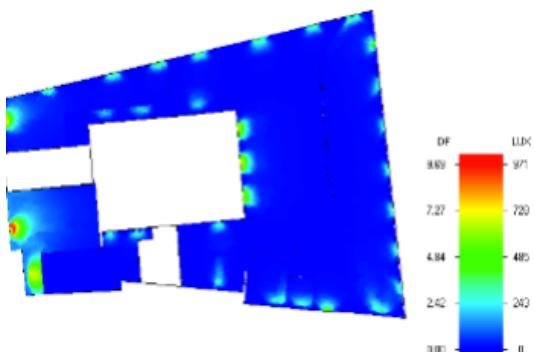
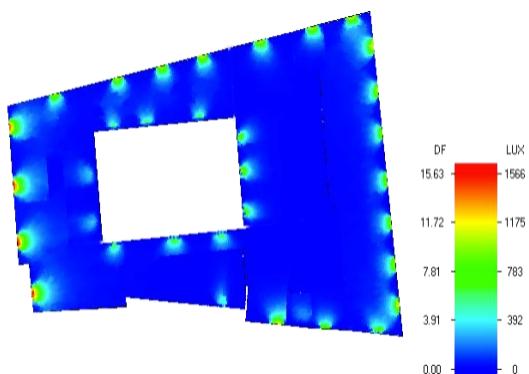
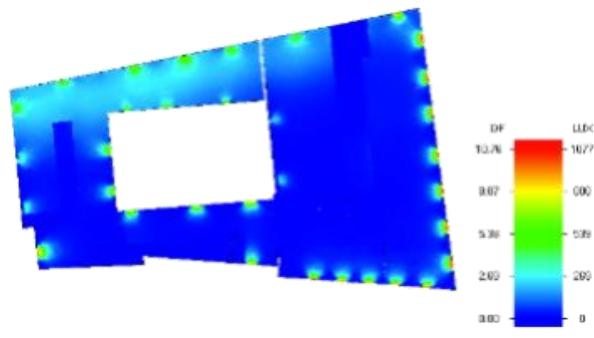
Figure 8. Availability of daylight

The availability of natural light is limited, as shown in Figure 8, due to the compactness of the building, but also because numerous buildings are located around it. The surrounding buildings constitute obstructions that hinder the entry of natural light through the windows, therefore artificial lighting consumptions are consistent.

Based on the results of this analysis it would therefore be useful to improve the performance of the lighting system, specifically by modifying the lighting fixtures.

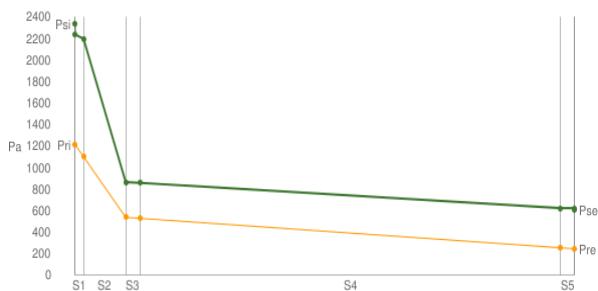
Figure 9. Diagram of Glaser of vertical walls

In this case the thermal insulating panel applied is a 60 mm thick polyurethane polyis foam, with Polytwins coatings on both sides, coupled to a 12.5 mm drywall slab. With the new configuration the external walls present a thermal transmittance value of $0.27 \text{ W/m}^2 \text{ K}$, and no condensation phenomena occur as confirmed in Figure 9.

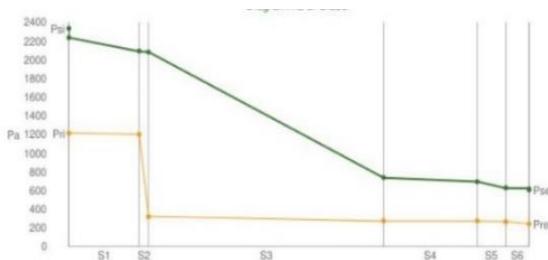
Figure 10. Diagram of Glaser for wood cover

A 100 mm EPS sheet plus 40 mm ventilation chamber, coupled with 12 mm OSB panel was installed both on the wood and the brick-concrete covers under the tiles. This is a system for thermoventilation of civil and industrial roofs which, thanks to its configuration, ensures considerable advantages in terms of living comfort and ease of installation. With the new configuration the covers present a thermal transmittance value of 0.28 and $0.245 \text{ W/m}^2 \text{ K}$ respectively. This intervention solves the condensation phenomena, as shown in Figures 10 and 11.

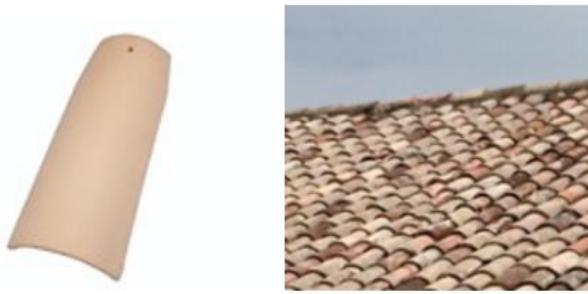
Figure 12. The chosen tile and the existing cover

In Figure 12 a picture of the chosen tile compared with the existing cover is shown. The chosen tile has a solar reflectance of 0.63 and a thermal emissivity of 0.83.

They are based on pigments applied on a highly reflective substrate in the infrared spectral band. Since only the radiation that falls within the visible spectrum influences the chromatic feature of a surface, the cool colors would have the same visible appearance of traditional materials, but at the same time give a much higher solar reflectance. Starting from these considerations a tile with a similar color to that of the existing roof tile was chosen, in compliance with the requirements of the historic restrictions regulating the building.

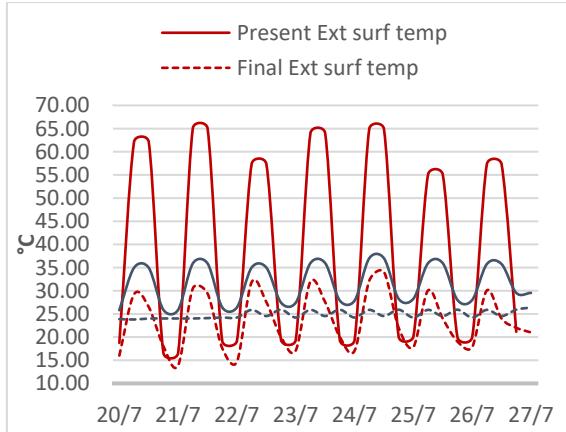
Figure 13. Temperature trend before and after cool material installation

Through the installation of cool materials, a more comfortable thermo-hygrometric condition takes place in the attic rooms, as shown in Figures 13 which summarizes the temperature trend of a typical summer week (July 20th - July

27th). In fact, in the final configuration, after applying cool materials on the cover, both the external surface temperature and the interior air temperature are characterized by very low attenuation when compared to the corresponding trend of the current configuration.

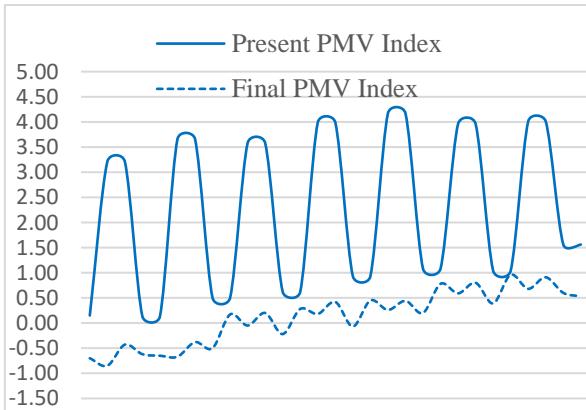
Figure 14. PMV index before and after cool material installation

Furthermore, Figure 14 shows the PMV index in the attic rooms before and after the installation of cool materials during the same typical summer week. In the final configuration the PMV index is very close to the optimal value of 0 for the entire period.

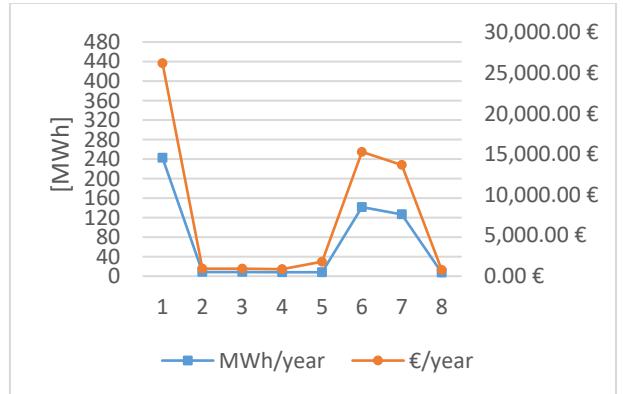
Figure 15. Annual gas consumption

The gas and electricity consumptions have been calculated for each configuration of the building. The results are shown respectively in Figures 15 and 16.

It is evident that all the considered interventions would result in a significant reduction of gas consumption. Configurations 2, 3, 4 and 5 have a very low gas consumption because the heating system uses electricity whose consumption, is, in fact, higher than configuration 1.

Configurations 6, 7 and 8 seem to be preferable from an energy saving point of view.

Configurations 6 and 7 allow respectively a gas consumption reduction of about 42 and 48 % and an electricity reduction of 15% in both cases if compared with configuration 1.

Finally, configuration 8 is characterized by a very small gas consumption (- 97%) and acceptable electricity consumption (+ 28 %).

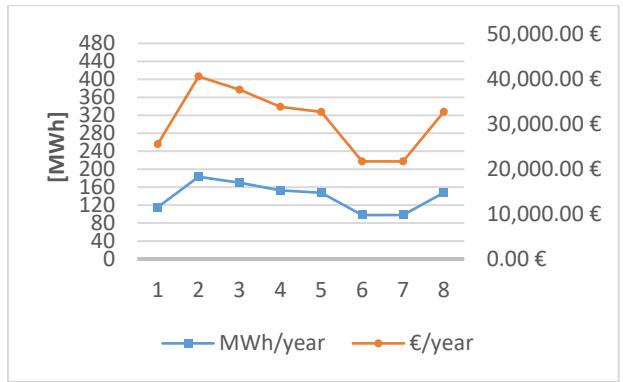
Figure 16. Annual electricity consumption

Obviously the electricity consumption is decreasing proceeding from configuration 2 to 5. It is about + 59% in configuration 2 with respect to the existing state of the building, + 47% in configuration 3, + 32% in configuration 4 and + 28% in configuration 5.

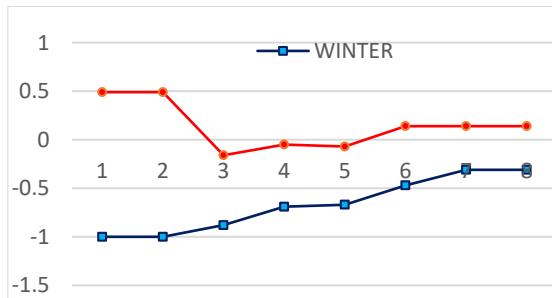
Figure 17. PMV index in winter and summer conditions

The energy improving interventions will result more comfortable conditions from a thermo-hygrometric point of view. This is underlined by the results of the analysis regarding the PMV index, as shown in Figure 17. Both in winter and summer conditions, the PMV index is in the optimal range between -1 and 1. In particular, configurations 7 and 8 seem to give the best results.
