## **The Research on Flexural Behavior Experiment of Pre-Stressed Glue-Lumber Beams after Long-Term Loading**

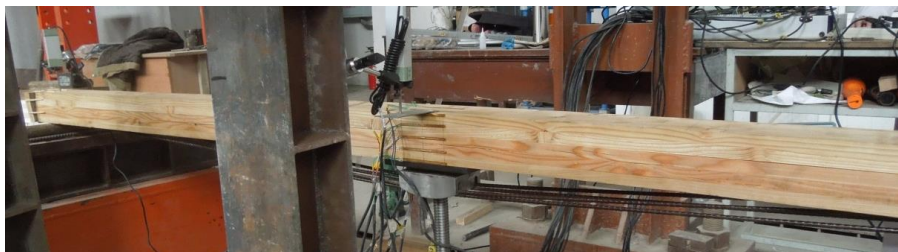
Fig.3. Pre-stressed glue-lumber beam

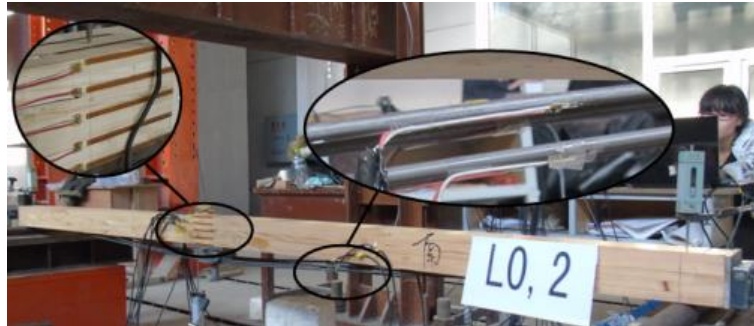
To measure the deflection of beam-ends and the mid-span, two LVDTs with a range of 50mm was put in the support of each beam-end. Another LVDT with a range of 200mm was put in the mid-span. In order to momentarily monitor the stress change of glue-lumber beams and steel wires, five 100mm×3mm strain gauges were glued to each side of the mid-span. And two strain gauges of the same size were glued to the top of the mid-span. One 20mm×3mm strain gauge was glued to each steel wire. And a temperature compensation piece was glued to the glue-

lumber and the pre-stressed steel wire under the same experiment condition. The detailed position of the strain gauge is shown in Fig.4. During the process of loading, the deflection change of beam-ends and the mid-span, and the stress change of the pre-stressed steel wire and glue-lumber beams are simultaneously collected by multifunctional static-resistance strain gauge system of JM3813.

Fig.4. The illustration of strain gauge

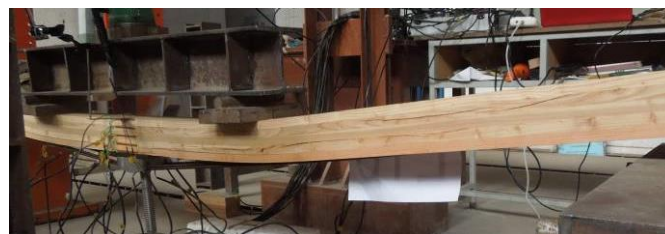
During the preliminary stage of loading, the deflection of the beam displayed linear increase as the loading increased. After that, with the increase of loading, the deformation remarkably increased, and displayed elastic-plastic characteristics, as is shown in Fig.5. With the continuation of loading, clear cracking sound could be heard, but the surface of the beam did not display apparent cracks or damages; later when the loading further continued, the re-distribution of stress due to cracks in the preliminary stage helped stop the cracking and rendered the beam stable again; when the loading further increased by several grades, the beam gave out comparatively loud noise, with obvious cracks in interlaminates or at the beam bottom, as is shown in Fig.6.

Fig.5. Plastic deformation of the beam

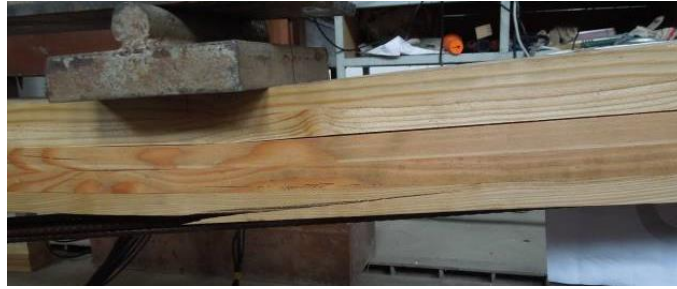
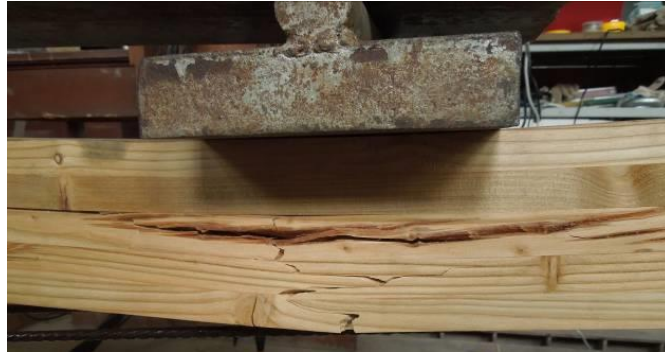
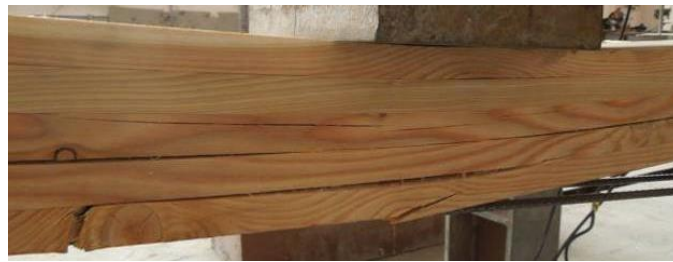
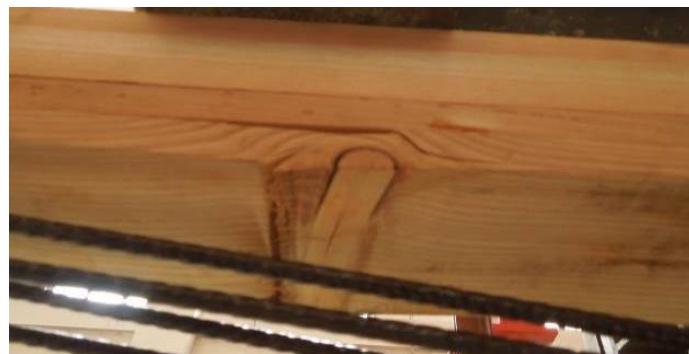
Fig.6. Failure mode of the first group

(a) Failure mode of beam  $L_{A1-2}$

(b) Failure mode of beam  $L_{A1-4}$

(c) Failure mode of beam  $L_{A1-6}$

(d) Failure mode of beam  $L_{A2-4}$

Number	$F_c/kN$	failure mode
L <sub>A1-2</sub>	5.90	tension failure of the third point shown in Fig.6(a)
L <sub>A1-4</sub>	8.21	tension failure of the third point shown in Fig.6(b)
L <sub>A1-6</sub>	13.23	Cracks in adhesive laminate causing tension failure of the beam bottom, shown in Fig.6(c)
L <sub>A0-4</sub>	5.65	Skew cracks in the laminate close to the beam bottom
L <sub>A1-4</sub>	8.21	tension failure of the third point shown in Fig.6(b)
L <sub>A2-4</sub>	15.69	Cracks in the knag of beam bottom causing penetrating cracks shown in Fig.6(d)

Fig.6, Fig.8 and Fig.9 show that the main failure modes of pre-stressed glue-lumber beams were: tension failure of bottom fibers, shown in Fig.6(a), (b) and 9(b); fiber damage on beam top under compression, shown in Fig.8(b), 9(c); glue failure of laminate or horizontal crack, shown in Fig.6(c), (d), 9(a).

After statistical analysis, failure mode of first group is mostly tension failure of bottom fibers, and the second group is mostly fiber damage on beam top under compression. This can be accounted for by the fact that the control on pre-stressed glue-lumber beams after long-term loading increased the stress of pre-stressed steel wire. According to the condition of cross-section

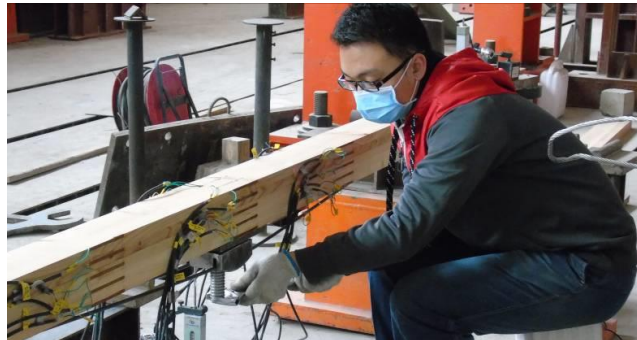
Before loading, the pre-stress control was conducted, and the deformation of the mid-span of the beam was adjusted to the original size at the beginning of the long-term loading, as shown in Fig.7.

Fig.7. Pre-stress control of pre-stressed glue-lumber beam

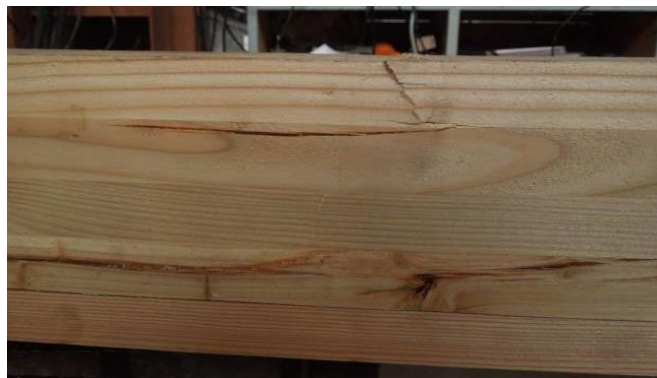
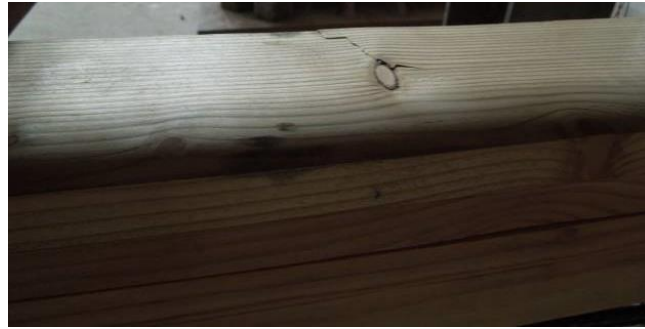
Fig.8. Failure modes of second group

(a) Wrinkles on the side surface of three dividing points

(b) Skew cracks on the surface of the beams

Number	$F_c$ /kN	failure mode
L <sub>B1-2</sub>	14.80	tension failure at the third point of the beam bottom
L <sub>B1-4</sub>	23.50	Wrinkles at the third point on the side surface of the beam shown in Fig.8(a)
L <sub>B1-6</sub>	29.80	Skew cracks on the top of the beams shown in Fig.8(b)
L <sub>B0-4</sub>	17.44	tension failure at the third point of the beam bottom
L <sub>B1-4</sub>	23.50	Wrinkles at the third point on the side surface of the beam shown in Fig.8(a)

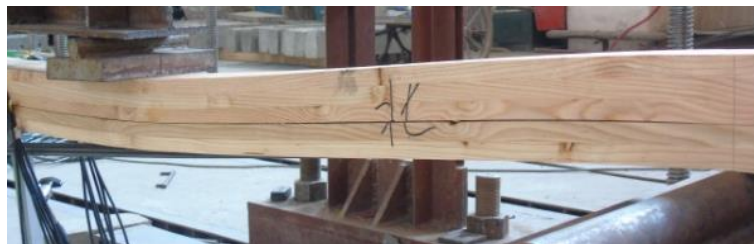
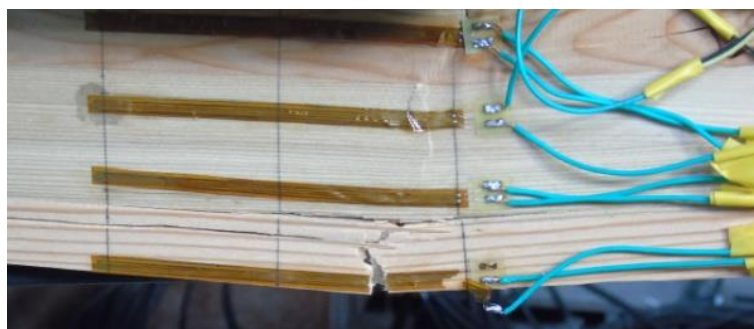
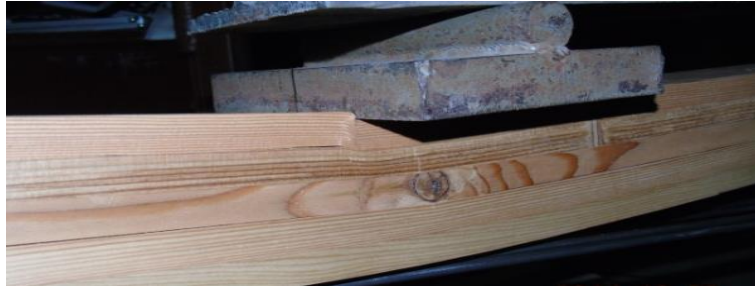
Fig.9. Failure modes of third group

(a) Glue failure of the laminate

(b) Tension failure of the beam bottom

(c) Tension failure of the beam top

Number	$F_c$ /kN	failure mode
LC1-2	21.02	glue failure of one beam, shown in Fig.9(a) tension failure of two bottom fibers, as shown in Fig.9(b)
LC1-4	23.61	glue failure of one beam, shown in Fig.9(a) tension failure of one bottom fiber, shown in Fig.9(b) fiber damage on beam top under compression, as shown in Fig.9(c)
LC1-6	24.06	glue failure of one beam, shown in Fig.9(a) tension failure of one bottom fiber, shown in Fig.9(b) fiber damage on beam top under compression, shown in Fig.9(c)
LC0-4	18.24	glue failure of one beam, shown in Fig.9(a) tension failure of two bottom fibers, as shown in Fig.9(b)
LC1-4	23.61	glue failure of one beam, shown in Fig.9(a) tension failure of one bottom fiber, shown in Fig.9(b) fiber damage on beam top under compression, as shown in Fig.9(c)
LC2-4	23.00	fiber damages on beam top under compression, shown in Fig.9(c)

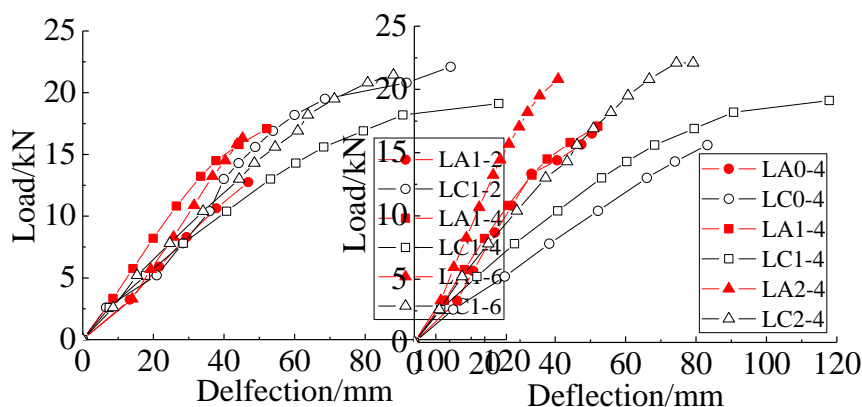
A load-deflection curve was formed for beams after both long-term loading experiment and short-term loading experiment and beams after only short-term loading, namely, the first and the third group, shown in Fig.11. For convenience of comparison, it is decreed that deformation downward is positive and deformation upward is negative; at beginning of the loading, the deformation of the mid-span is zero.

Fig.11. Load-deflection curves of first and third group

Fig.11 shows that the stiffness of beams that were long-term loaded was basically the same with that of beams that were not long-term loaded, but the beams deformation capacity decreased. The pre-stress being the same, but the number of pre-stressed steel wire being different, compared with beams that were not long-term loaded, the deformation from long-term loading that reached ultimate load decreased by 48.58%~55.76%; the number of steel wires being the

same, when the pre-stress increased from 0 to 6.158kN, the deformation from long-term loading that reached the ultimate load decreased by 39.47%~55.76%.
